M.V. “ APL SINGAPORE ”

LASHING SURVEY REPORT

Report No. (18)0402SA

CARGO LOADING AND SECURING REPORT

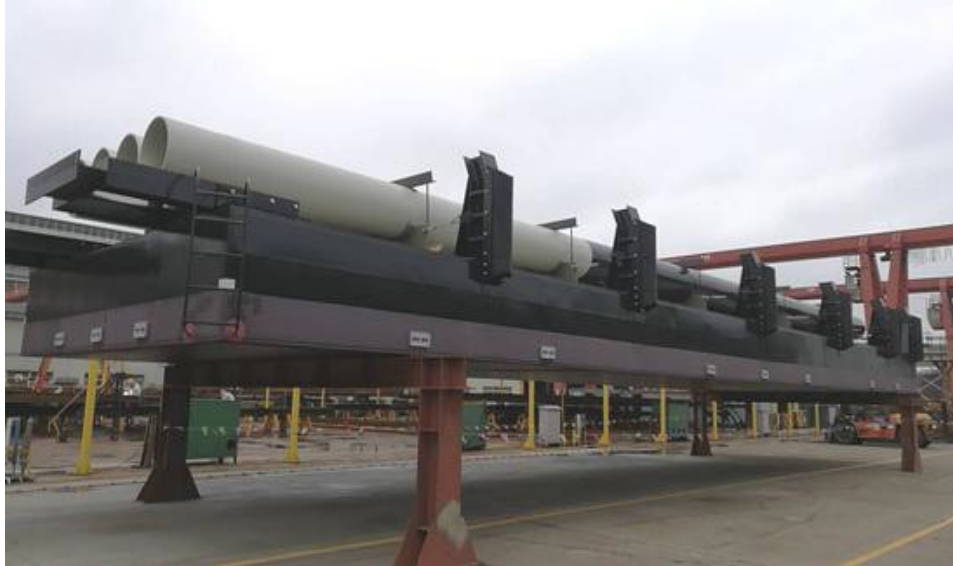
General view of cargo in factory

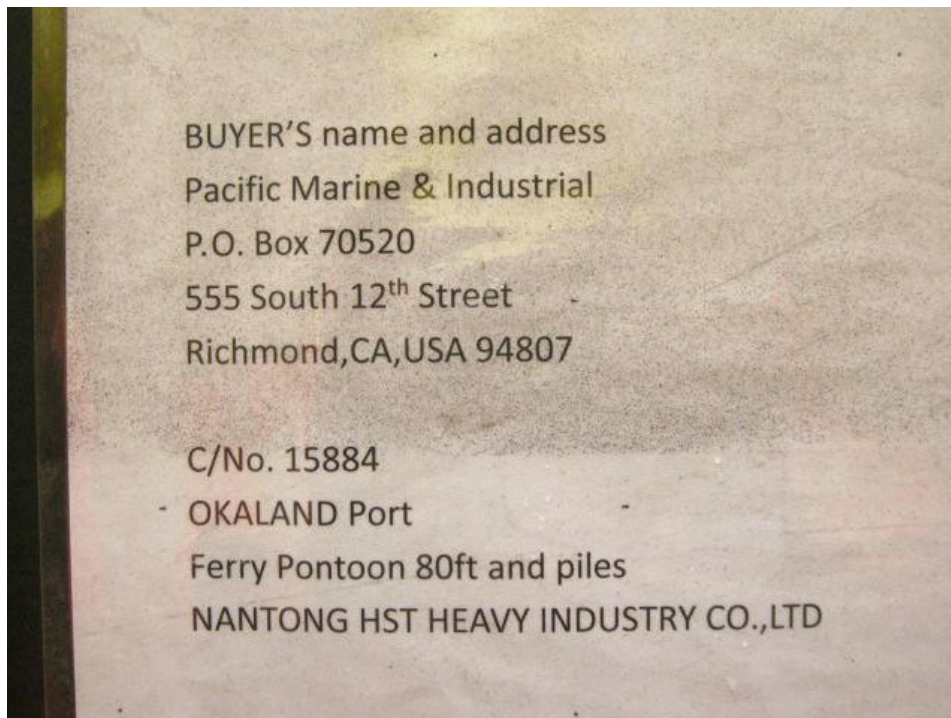
Cargo markings

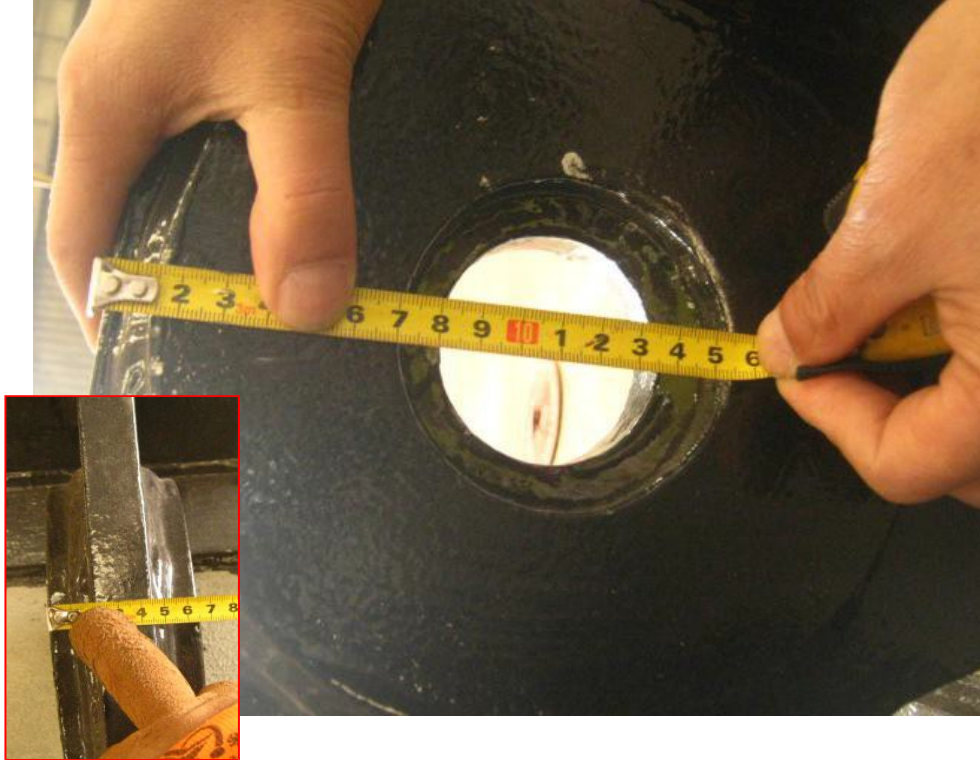
Lifting rings on deck

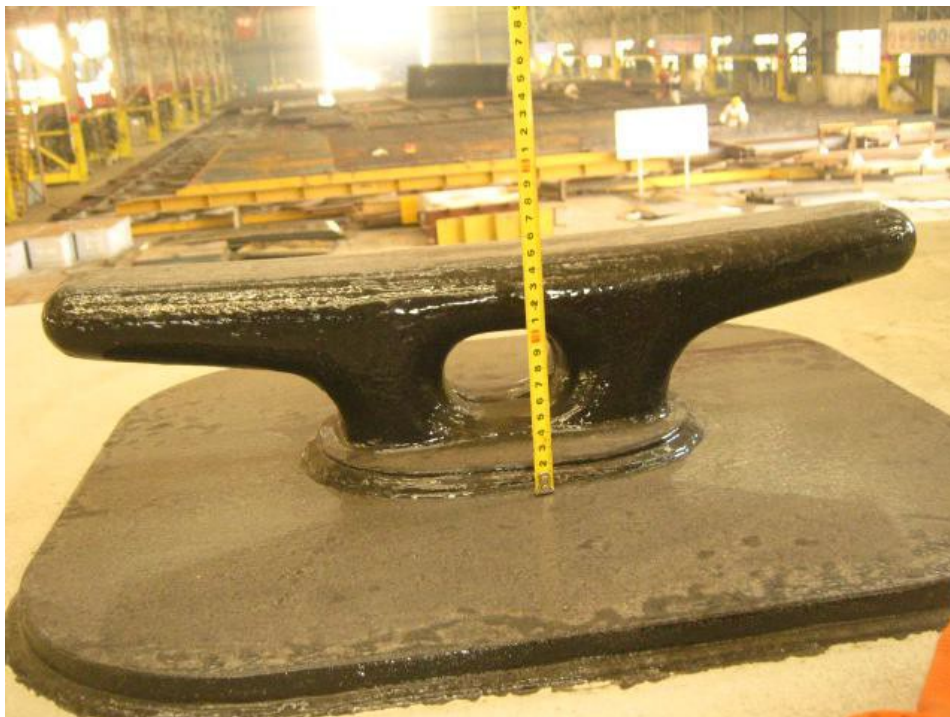
Mooring cleat on deck

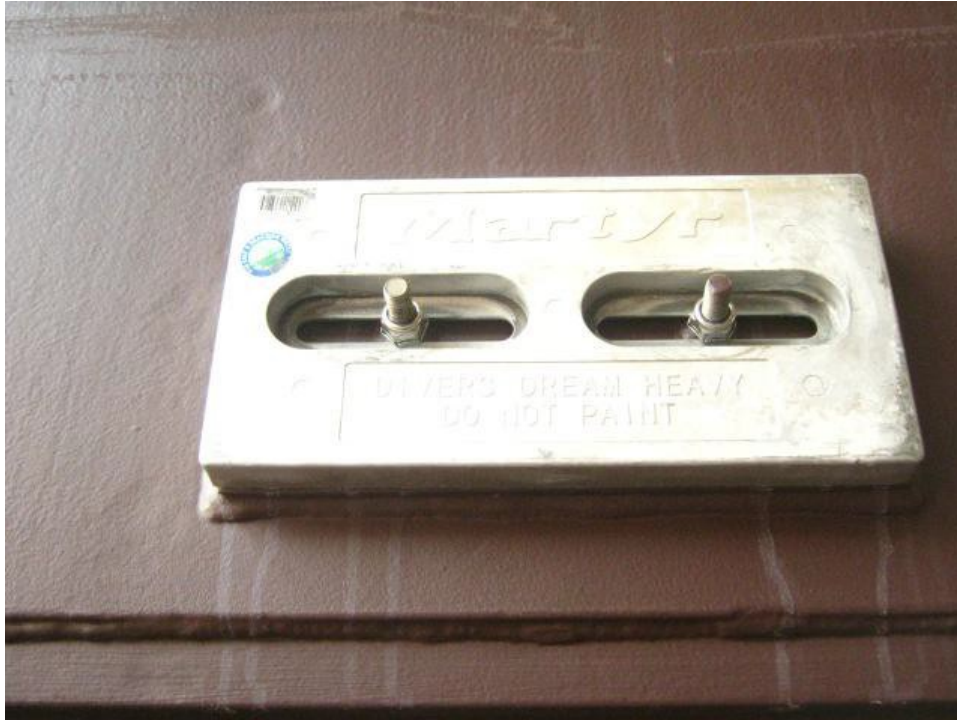
Zinc pieces on the hull

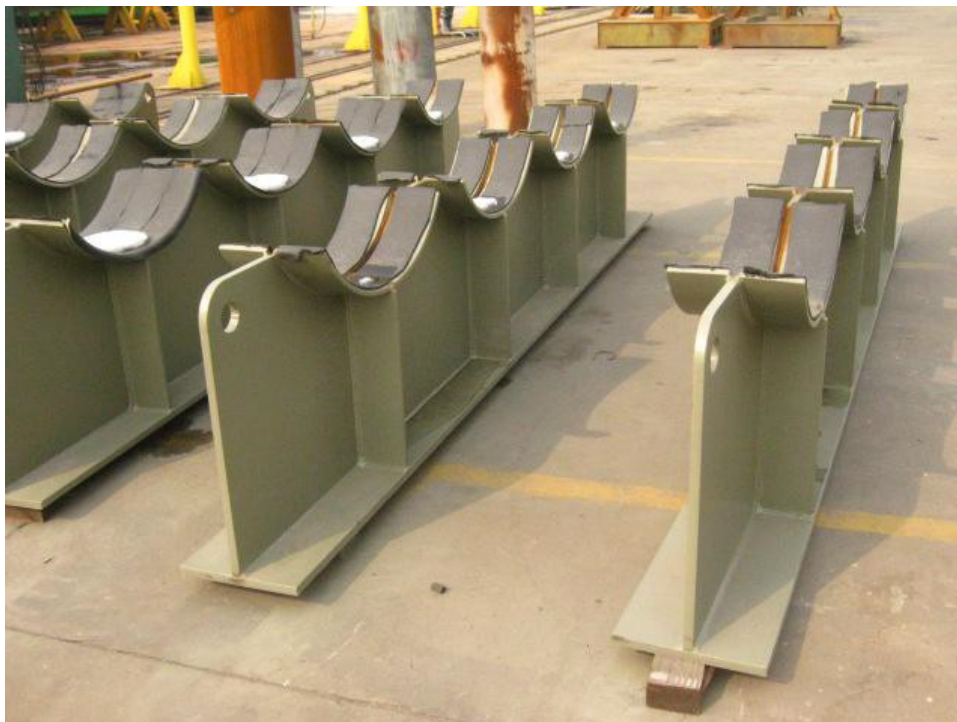
Steel cradles for pipes' placed

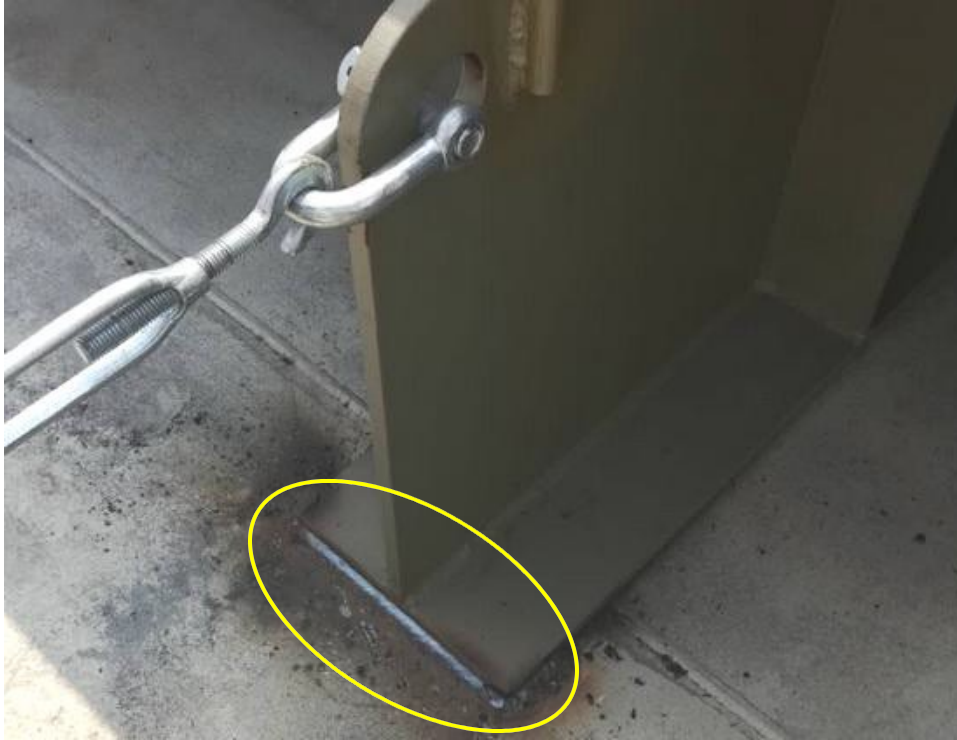
Cradles were secured and welded on deck

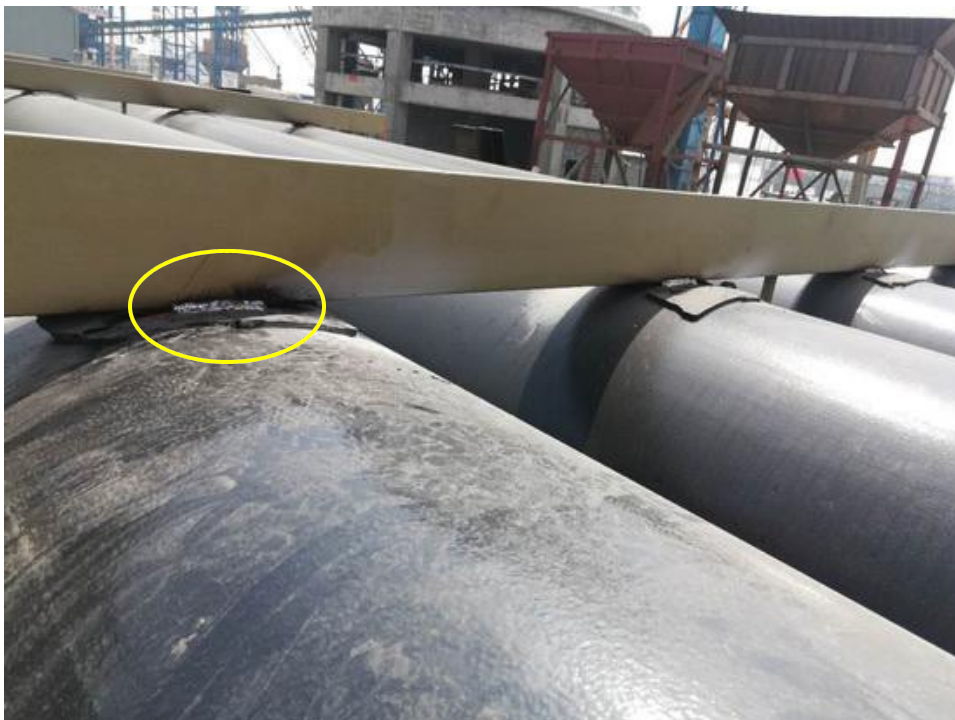
Pipes were welded on to the cradle's top angle steel

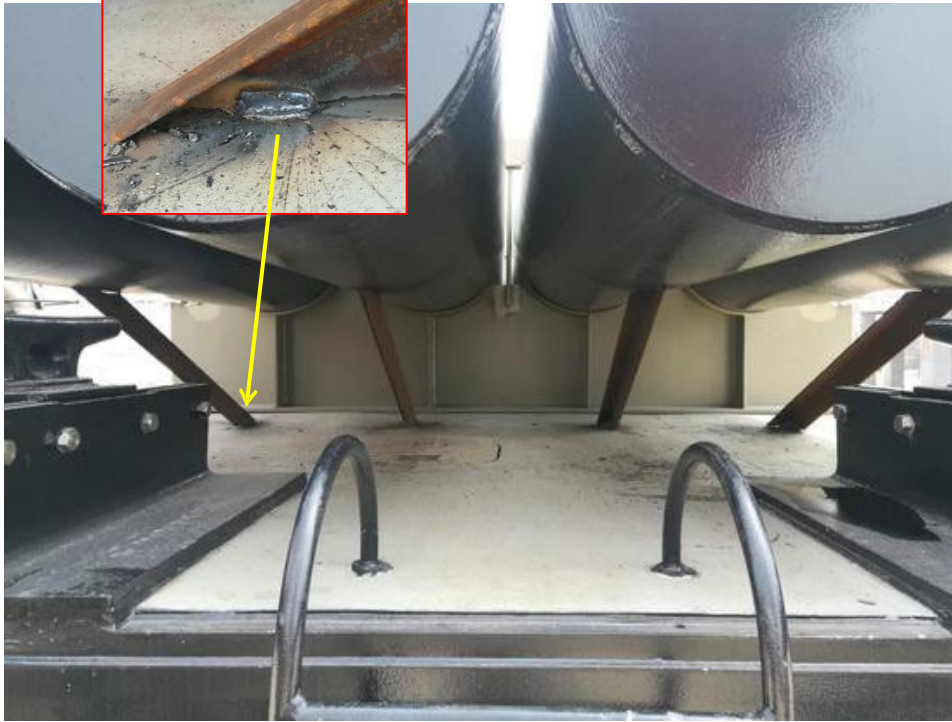
Pipe's one end was welded on to the deck with L type angle steel

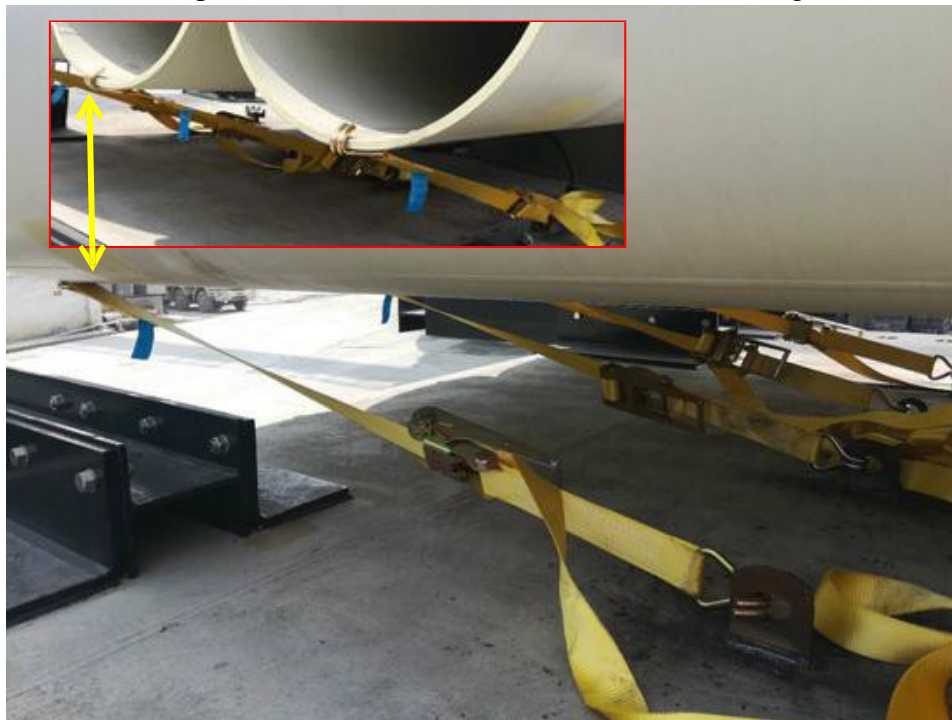
Pipe's another end was secured onto the deck ring

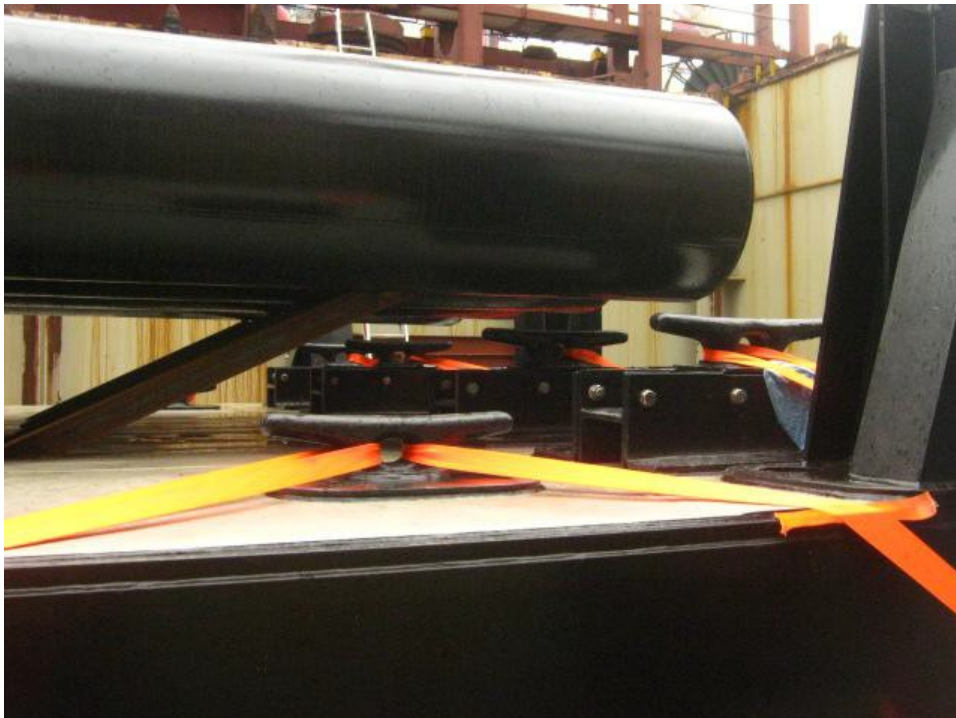
Lashing on the cleats

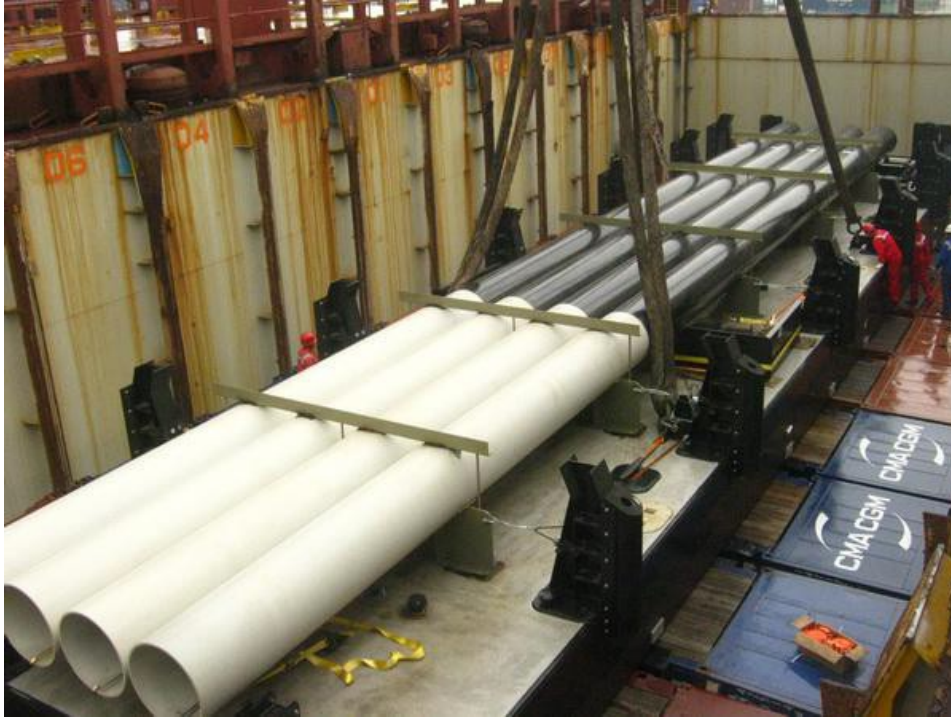
Cargo was properly stowed under deck at bay 58

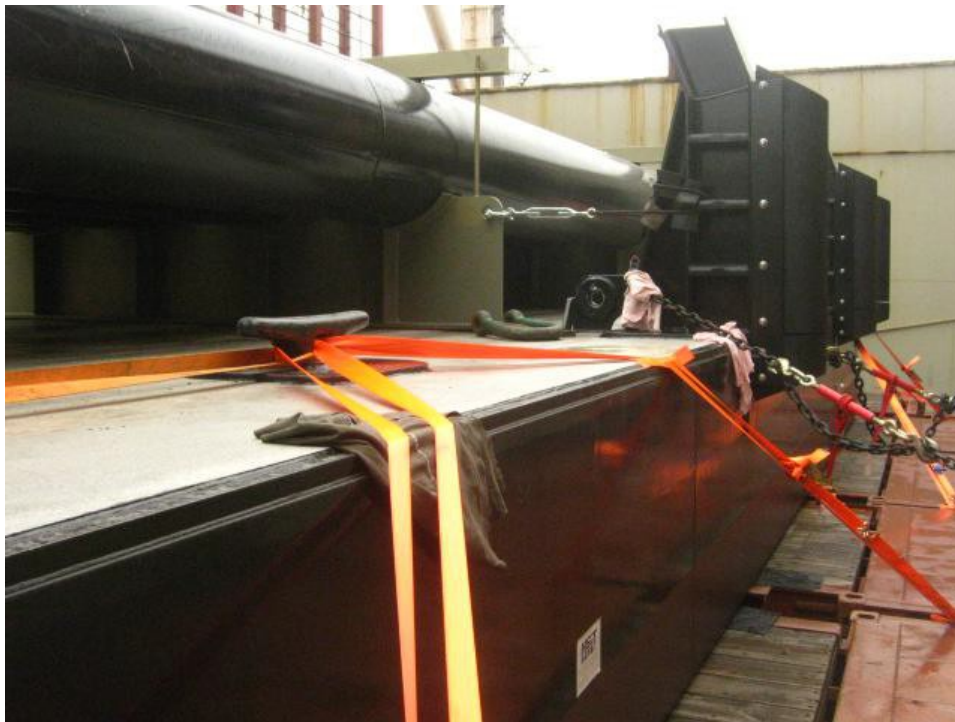
Padding for the lashing where necessary

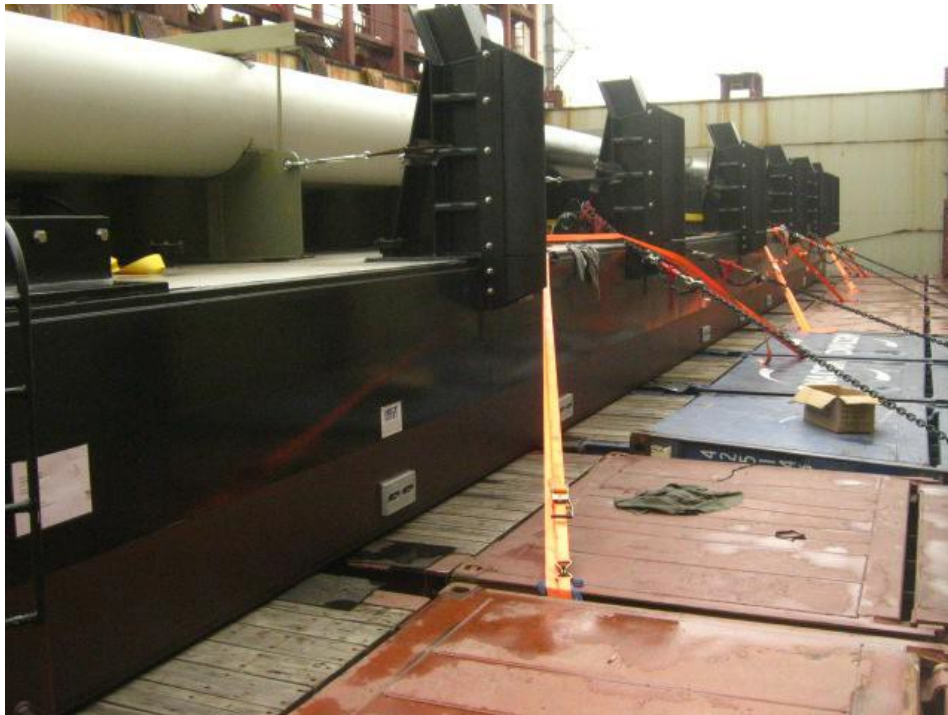
Cargo was properly stowed and secured under deck at bay 58

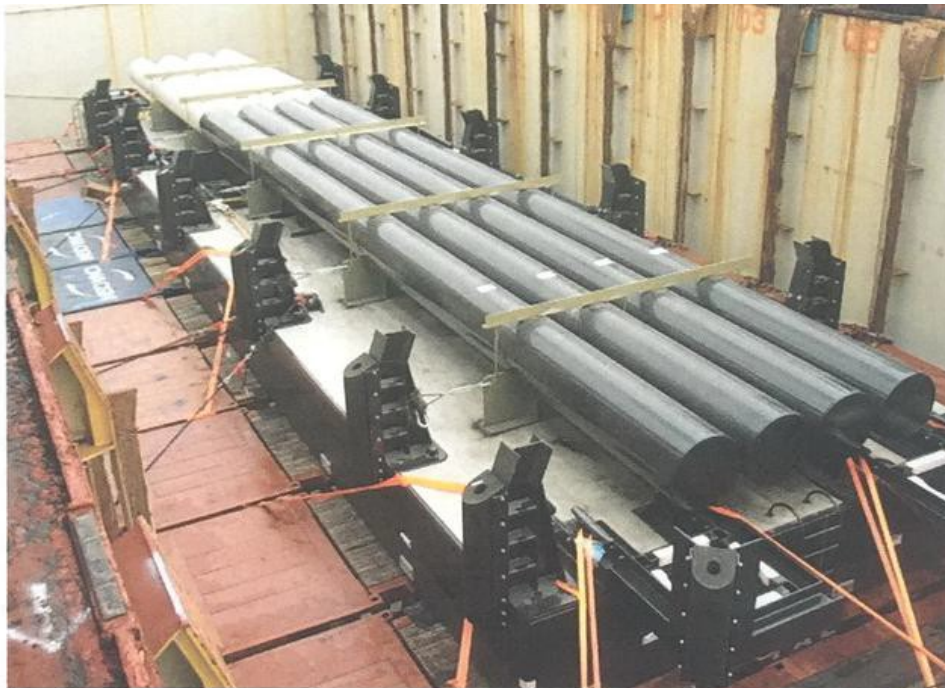
Cargo was properly stowed and secured under deck at bay 58
